# Issues of Authenticity: Conservation of Chinatown Architecture in Ketandan Village, Yogyakarta, Indonesia

Fitri Prawitasari & Amos Setiadi

Department of Architecture, Universitas Atma Jaya Yogyakarta, Indonesia

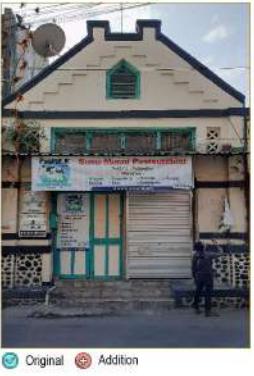
### A. Kwan Nio Tio Shop House

**Roof**: The stepped gable, a characteristic of the Indo architecture, is still original and in good condition, but the paint color does not match the original color. There are cracks in the plaster due to wild plants.

**Canopy**: The current canopy is made of galvanum. The original steel sills holding the canopy are still present.

**Wall**: The walls have been repainted with a color similar to the original. There is an additional wall on the front right and left sides. The structure on the front wall is tilted due to wild plants that have eroded the walls.

**Doors & Windows**: The previously open terrace is now covered with a wooden and rolling door that is still in good condition.

**Floor**: The key tiles are still original, although several others on the outer side are already damaged.

**Colours Guideline**: Adjust the color of the gable to match the original color.

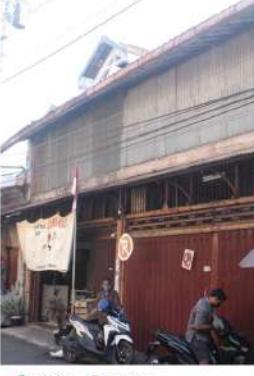
### B. Ketandan 5 and 7 Shop House

**Balcony Ceiling**: 2<sup>nd</sup> Floor: The corrugated iron is messy and rusty, but the gutter is still in good condition. And 1<sup>st</sup> floor: The corrugated iron is in good condition with iron console.

**Wall**: 1<sup>st</sup> & 2<sup>nd</sup> floor: The wall is poorly maintained, with the overall walls already dull and messy, while the plaster has been eroded to reveal the smell of brick.

**Balcony railing Fence**: The balcony railing is still original, although in some places. And the balcony covered by corrugated iron.

**Canopy**: The corrugated iron still in good condition.

**Doors & Windows**: 1<sup>st</sup> floor: folding door in good condition. And 2<sup>nd</sup> floor: wood doors still in good condition but rusty.

**Floor**: 2<sup>nd</sup> floor: wood floor still in good condition but rusty.

**Colours Guideline**: Replacing it with the same physical form but better material, such as galvanum.

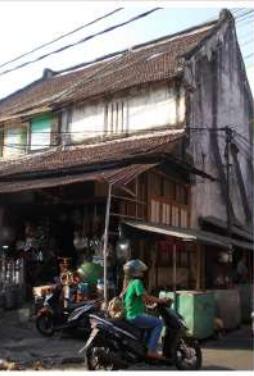
### C. The Shop House 41

**Roof**: 1<sup>st</sup> floor: The cover of the Vlaam roof tiles has some broken parts, causing leaks. And 2<sup>nd</sup> floor: The roof ridge has leaks, while the covering of the Vlaam tiles is encrusted and damaged in some places.

**Wall**: 1<sup>st</sup> & 2<sup>nd</sup> floor: The wall is poorly maintained, with the overall walls already dull and messy, while the plaster has been eroded to reveal the smell of brick on the East side wall.

**Windows**: The condition is still good.

**Canopy and Gutter**: The condition of the zinc canopy is no longer neat and has rusted.

**Doors**: 1<sup>st</sup> floor: The wooden panel of the door is still good, but the paint has peeled off and faded. And the iron vent shutters are dirty with moss due to rainwater that leaks from the roof. The paint has also faded.

**Floor**: 1<sup>st</sup> floor: The stamped concrete floor is still original but cracked and eroded. The terracotta floor is also uneven, with some broken tiles in several places.

**Colours Guideline**: 2<sup>nd</sup> floor: Patching and repairing the roof ridge as well as replacing damaged tiles. And 1<sup>st</sup> floor: Replacing old roof tiles with new Vlaam roof tiles.

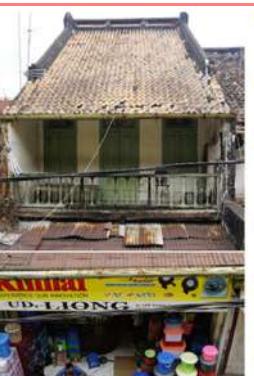
### D. UD. Liang Shop House

**Roof**: Waterproofing is required between the roof ridge and tiles to prevent leakage. The Vlaam tiles on the balcony are messy, while some are broken, causing leakage and the wooden frame to start deteriorating.

**Wall**: 2<sup>nd</sup> floor: The paint and plaster are dirty, faded, and damaged with some peeling... 1<sup>st</sup> floor: The wall paint has faded, and the plaster is peeling due to dampness.

**Balcony railing Fence**: The tiles are dirty, have crusty deposits, and are poorly maintained.

**Canopy and Gutter**: The corrugated iron is messy and rusty, but the gutter is still in good condition.

**Doors & Windows**: 2<sup>nd</sup> floor: The door is still original with double door leaves, but the inner glass of the leaf is already broken. And the windows are still original with faded paint. And 1<sup>st</sup> floor: The folding door is rusty, the paint has faded, and the rails are slightly jammed.

**Floor**: 2<sup>nd</sup> floor: The tiles are dirty, have crusty deposits, and are poorly maintained. And 1<sup>st</sup> floor: The ceramic motif has faded, and some corners are broken.

**Colours Guideline**: Repairing the roof frame, which has started to decay due to leakage, and replacing the entire Vlaam tile roof.

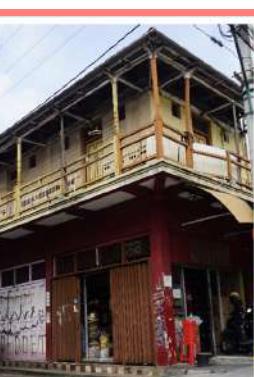
### E. Windyastuti Shop House

**Canopy**: 2<sup>nd</sup> floor: The original balcony canopy is tilted and damaged toward the wall. A new lightweight steel frame canopy has been added on top to protect from rain. And 1<sup>st</sup> floor: There is an addition of a plastic canopy that is cluttered.

**Balcony Ceiling & Railing**: The original balcony roof ceiling is no longer present, with only a small portion remaining at the edge. The wooden frame exposed to the rain has started to deteriorate and rot. And the balcony railing is still there, though some slots are missing, and the railing are tilting, while some are already damaged and rotten. The new paint color is inconsistent and has already peeled off or faded.

**Wall**: 2<sup>nd</sup> floor: The wall is black due to moss from the weather. And 1<sup>st</sup> floor: There are also some vandalism scratches.

**Doors and Vents**: 2<sup>nd</sup> floor: The wooden doors vents are still original and in good condition. And 1<sup>st</sup> floor: There are still original wood panel doors in good condition but there is some vandalism. The iron folding doors are an additional element.

**Floor**: 1<sup>st</sup> floor: The new ceramic on the terrace floor is eroded and cracked at several points.

**Colours Guideline**: 2<sup>nd</sup> floor: Repairing the wood frame and the joints of the original canopy with the roof wall to prevent leaks. Using Vlaam roof tile covering 1<sup>st</sup> floor. The additional plastic canopy is removed.
