Re: Article

I attach proof of payment of USD 268 for publishing articles in ISVS e-journal 10.5; the authors' names are Fitri Prawitasari and Amos Setiadi.

This research used a qualitative method which involved identifying authenticity, as well as damage and handling of the building components. Data were collected through field surveys, documentation, and measurement of the buildings. Subsequently, it prepared developing plans for reconstruction and restoration, as well as plans for changes and additions to the components.

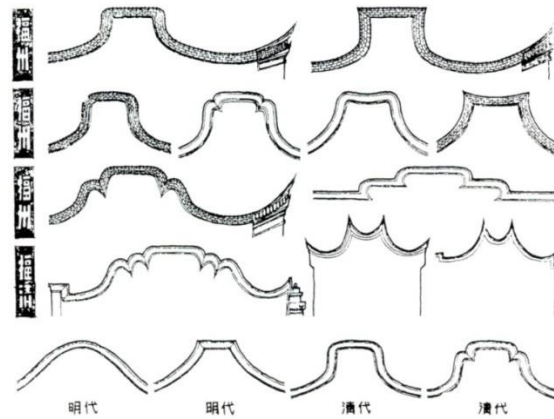
Fig 2: Shape of the side wall (*kopwand*)
Source: Knapp, in Kustedja (2014)

In the construction of the saddle roof with *kopwand*, the *gable wall*, and the *shan-qiang* wall also function as a firewall. The side edges of the wall are made much higher than the roof surface next to it, and this shape aims to prevent the spread of fire through the wooden roof structure when a neighboring building catches fire. The addition of height to the side wall (*kopwand*, *shan-qiang*) is higher than the *wuwungan* line and the roof plane. Usually, the top of the wall is decorated (Fig. 2). The decorations at the end of the *shan-hua* wall differentiate the social status of the occupants.

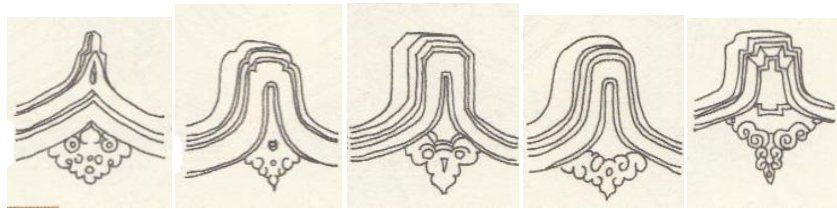
Fig 3: Symbols of fire/south, metal/north, wood/east, water/west, and earth/center Source: Knapp, in Kustedja,2014)
Source: Knapp, in Kustedja,2014)

The variety of ornaments found on the side walls symbolize beliefs and good hopes (immortal, Buddhist) (Fig.3).

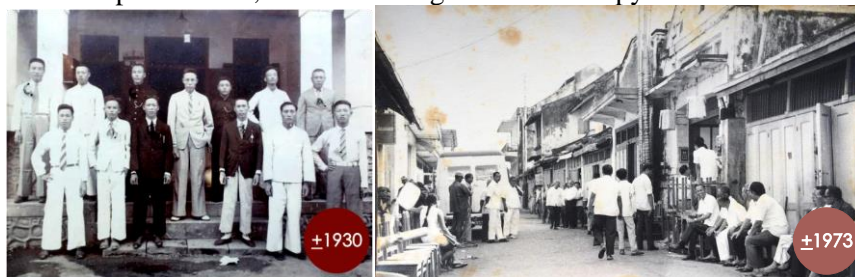
Fig 5: Kwan Nio Tio Shop House in 1930 and 1973

Kwan Nio Tio Shop House is located on Ketandan Lor Street No. 58. The building consists of one floor and combines Chinese as well as Dutch architectural styles. The typical feature of the Dutch-style Kwan Nio Tio shop-house is the stepped gable and the gable window on the tympanum plane. The upper front part has a geometric pentagon-shaped rooster. Currently, the building facade has four folding doors with bovenlicht above it and is adorned with stained glass. Moreover, the walls of the building are plastered with exposed stone, and there is a galvalume canopy.

According to Fig 5, from the year 1930, the Kwan Nio Tio Shop House facade part has an open terrace as the living room with grand pillars, and the walls appear to be painted in a bright color white. There are doors and windows after the terrace. From 1973, a small part of the house as shown from the side has no visible grand pillars. There is a concrete canopy pulled by a steel cable and an open terrace. The facade damage of Kwan Nio Tio Shop House are as follows (Fig.6):

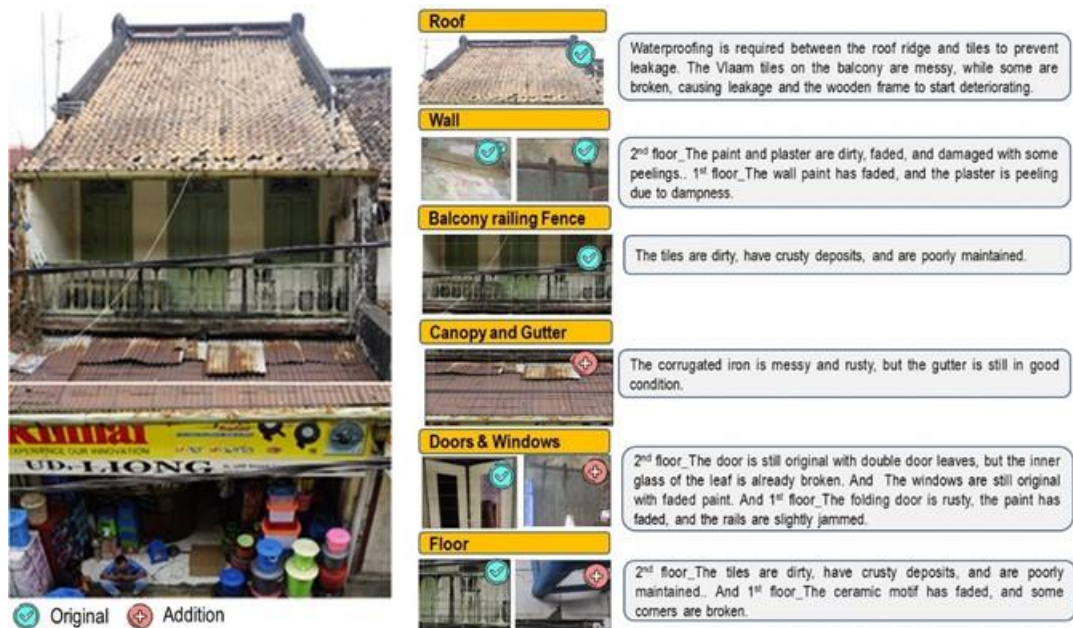
Fig 14: Identification of Facade Damage of the Liong Shop House

Liong Shop House is located on Lor Pasar Street, with a Chinese architectural style, and consists of two floors. The first floor is a grocery store, while the second is a warehouse. The damages to the Liong Shop House facade is shown in Fig 14.

Waterproofing is required between the roof ridge and tiles to prevent leakage. The Vlaam tiles on the balcony are messy, while some are broken, causing leakage and the wooden frame to start deteriorating.

2nd floor_The paint and plaster are dirty, faded, and damaged with some peelings. 1st floor_The wall paint has faded, and the plaster is peeling due to dampness.

The corrugated iron is messy and rusty, but the gutter is still in good condition.

2nd floor_The door is still original with double door leaves, but the inner glass of the leaf is already broken. And The windows are still original with faded paint. And 1st floor_The folding door is rusty, the paint has faded, and the rails are slightly jammed.

2nd floor_The tiles are dirty, have crusty deposits, and are poorly maintained. And 1st floor_The ceramic motif has faded, and some corners are broken.

- Repairing the roof frame, which has started to decay due to leakage, and replacing the entire Vlaam tile roof.

- 2nd & 1st floor_Cleaning the walls with sandpaper, patching up damaged plaster, filling with putty, and repainting it with white color.

- 2nd floor_Cleaning and repainting the door with the original green color and replacing the broken glass behind the door and Cleaning and repainting the window with the original green color. And 1st floor_Replacing the iron folding door with a wooden door and painting it green.

- 2nd floor_Cleaning the dirty balcony floor. And 1st floor_ Removing the ceramic tiles with a pattern on the terrace floor and replacing them with the same pattern as the interior floor (when the pattern is still available). It can be replaced with plain white color when the pattern is not available.

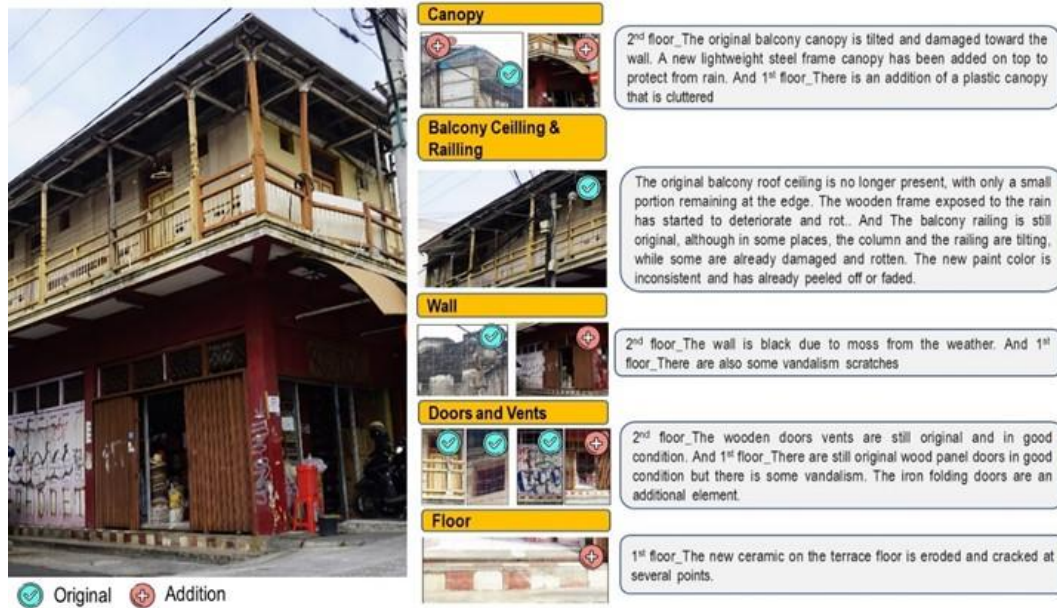
Fig 17: Identification of Facade Damage of the Windiastuti Shop House
Source: Author, 2023

Windiastuti Arjonosurjo shop house is located on the corner of Ketandan Lor No.7 and Suryaatmajan Street. This building is a fusion of Chinese and Dutch architectural styles. It consists of two floors, with the first currently used as a shop and the second as a warehouse. The facade damage for the Windiastuti Arjonosurjo shop house are shown in Fig 17.

2nd floor_The original balcony canopy is tilted and damaged toward the wall. A new lightweight steel frame canopy has been added on top to protect from rain. And 1st floor_There is an addition of a plastic canopy that is cluttered

The original balcony roof ceiling is no longer present, with only a small portion remaining at the edge. The wooden frame exposed to the rain has started to deteriorate and rot. And The balcony railing is still original, although in some places, the column and the railing are tilting, while some are already damaged and rotten. The new paint color is inconsistent and has already peeled off or faded.

2nd floor_The wooden doors vents are still original and in good condition. And 1st floor_There are still original wood panel doors in good condition but there is some vandalism. The iron folding doors are an additional element.

1st floor_The new ceramic on the terrace floor is eroded and cracked at several points.

2nd floor_Repairing the wood frame and the joints of the original canopy with the roof wall to prevent leaks. Using Vlaam roof tile covering. 1st floor_The additional plastic canopy is removed.

Replacing ceramic tiles with motif key or damaged tiles
